# Manhole Inspection Summary

Manhole # S15Q\_\_014MH

**Location** Address: **2747 WILKENS AV**

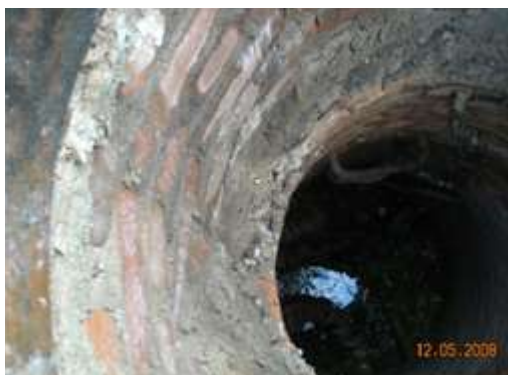
MISC.

Comments **LOCATED WITH METAL DETECTOR IN TALL GRASS; CHIMNEY/CORBEL OFFSET OF 2 INCHES**

CHIMNEY/CORBEL OFFSET OF 2 INCHES EVENLY AROUND

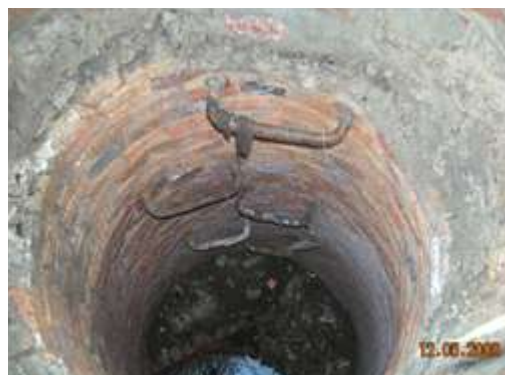
Defect 4

**Steps** Count: **5** Missing: **0** ☒ **Corroded**

CORRODED STEPS

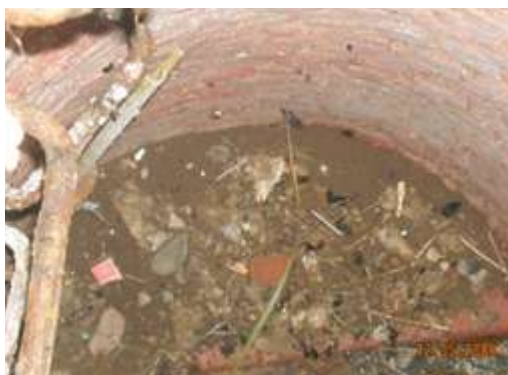
Defect 3

Condition: ☐ Sound ☐ Cracked ☐ Root Intrusion ☐ Deteriorated ☐ Leaks ☒ **Debris**

DEBRIS ON BENCH

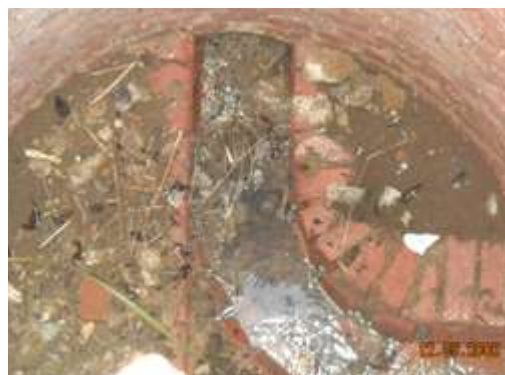
Defect 2

Condition: ☐ Sound ☐ Cracked ☐ Root Intrusion ☐ Deteriorated ☐ Leaks ☒ **Debris**

DEBRIS IN CHANNEL

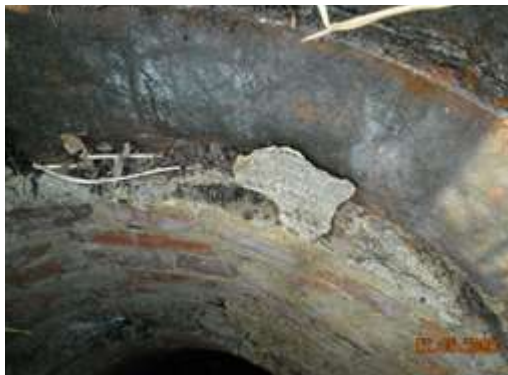
### Defect 1

**Frame** Offset: **1.5** (in.) Condition: ☒ Sound ☐ Cracked ☐ Leaks

FRAME OFFSET

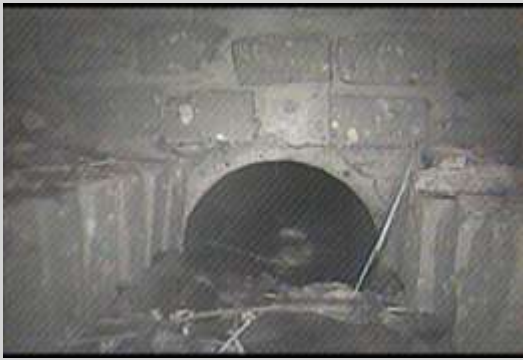
12 O'Clock Outflow

Pipe Height: **8.4** (in.) Rod and Bar (Angled)  
Pipe Material: **Clay** ☐ Pipe Lined  
Invert Depth: **11.12** (ft.) Flow Characteristics: **Slow**  
Deposits: ☐ None ☐ Mud ☐ Sludge ☒ **Debris** ☐ Grease  
Silt Depth: **2** (in.) Deposits Extent: **Medium**  
Infiltration: **None** Pipe Seal Cond: **Sound**

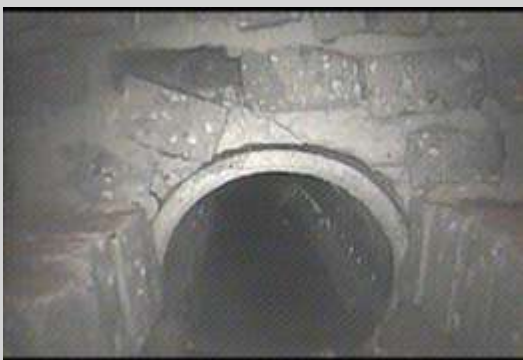
3 O'Clock Inflow

Pipe Height: **8.4** (in.) Rod and Bar (Angled)  
Pipe Material: **Clay** ☐ Pipe Lined  
Invert Depth: **10.75** (ft.) Flow Characteristics: **Slow**  
Deposits: ☒ **None** ☐ Mud ☐ Sludge ☐ Debris ☐ Grease  
Silt Depth: **0** (in.) Deposits Extent:  
Infiltration: **None** Pipe Seal Cond: **Cracked**
